**Flood Control Project Maintenance  
Levee Inspections**

**Fall 2018 Levee Maintenance Deficiency Summary Report**

<b>RD0544</b>	Overall LMA Rating	Total LMA Miles						
<b>Reclamation District No. 0544 Upper Roberts Island</b>	<b>U</b>	<b>10.20</b>						
Rated Item	Maintenance Deficiency				Enforcement		Design & System Obsolescence	
	M Miles	U Miles	M + 4U Miles	Threshold %	M Miles	U Miles	M Miles	U Miles
<i>Earthen Levee</i>								
Vegetation	1.18	4.95	20.98	205.66%		0.07		
Trim / Thin Trees	0.24	0.09	0.60	5.88%				
Encroachments	0.02	0.02	0.10	0.98%	0.39	0.11		
Animal Control	0.57	0.27	1.65	16.17%				
Slope Stability	0.04	0.01	0.08	0.78%				
Erosion / Bank Caving	0.03	0.09	0.39	3.82%				
Crown Surface / Depressions / Rutting	0.22		0.22	2.16%				
Flood Preparedness & Training	0.10		0.10	0.98%				
<i>Interior Drainage &amp; Piping Systems</i>								
Erosion Areas		0.01	0.04	0.39%				
<i>Supplemental</i>								
DWR Erosion Survey	0.04		0.04	0.39%				
DWR UCIP Field Study					0.19	0.05		
<i>LMA Totals:</i>	2.44	5.44	24.20	237.22%	0.58	0.23	0.00	0.00

**Flood Control Project Maintenance  
Levee Inspections****LMA District Cover Sheet****Fall 2018 Levee Inspection Results****Rec

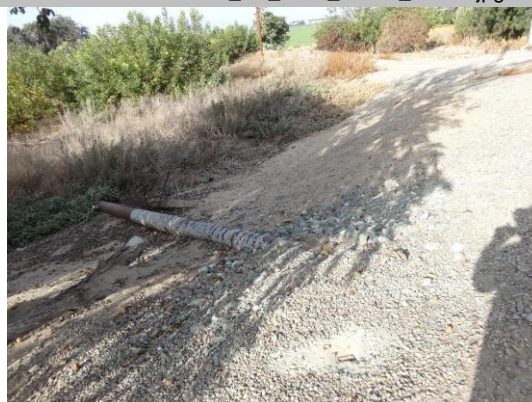
Photo 1 of 3 : UCIP\_FA\_2018\_23851\_41728.jpg

LM Start	0.01	Rating **	M	Issue No.	153	
LM End	0.01	Issue Type +	En	Location *		
Category	Supplemental			GPS Latitude/Longitude		
				Start	End	
Item	DWR UCIP Field Study			37.870296 °	37.870296 °	
				-121.329826 °	-121.329826 °	
DWR ID	24713					
Comment Code						
Inspector Comment						
FS_ID:23851						
DS_ID:24713						
EP_NO: N/A						
Repair Type: Non-Urgent						
Crossing Status: Found						
UCIP Comments: Appears abandoned.May need proper abandonment.Pipe exposed on landside slope.						
FIELD_STRUCT_DESC: *ABANDONED* 12-inch steel pipe of an unknown purpose through the levee, 2 feet below the crown. Appears abandoned. Only visible on the landside (LS) slope. No pipe or other features visible on the waterside (WS).						
FS Date: 10/29/2013

LS view: exposed 12-inch steel pipe on levee slope. Appears abandoned.

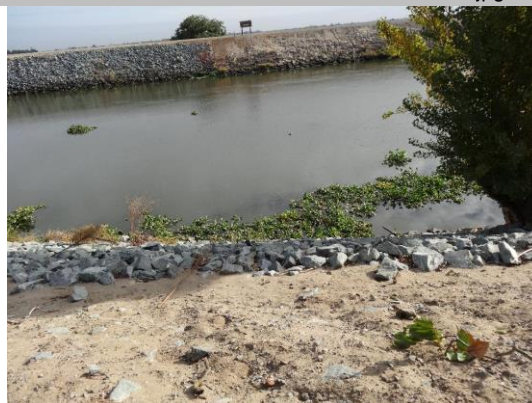
Photo 3 of 3 : UCIP\_FA\_2018\_23851\_41726.jpg

WS view: no pipe and appurtenances found on waterside.

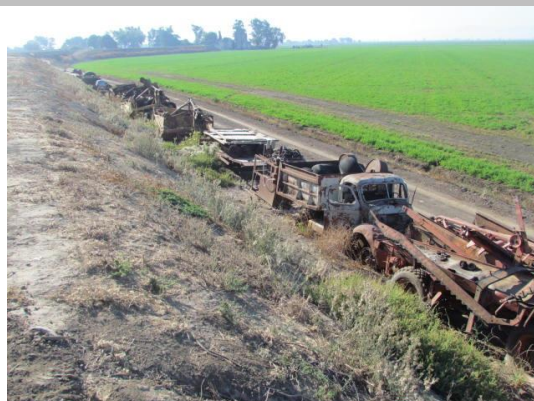
Photo 2 of 5 : FA\_2018\_RD0544\_108\_4\_20180906\_00006.jpg

Looking southwest at equipment stored at landward toe fall 2015.

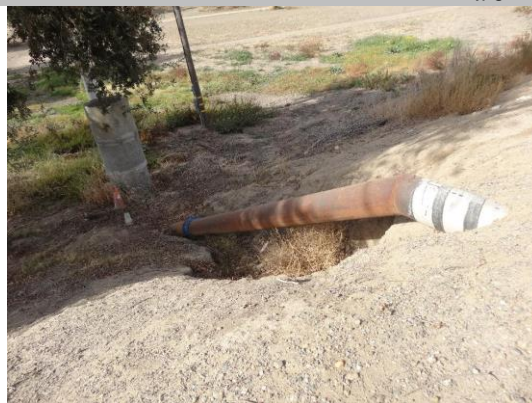
Photo 3 of 3 : UCIP\_FA\_2018\_53362\_42005.jpg

LS view: exposed pipe, concrete standpipe (left), service pole (top right) and eroded slope.

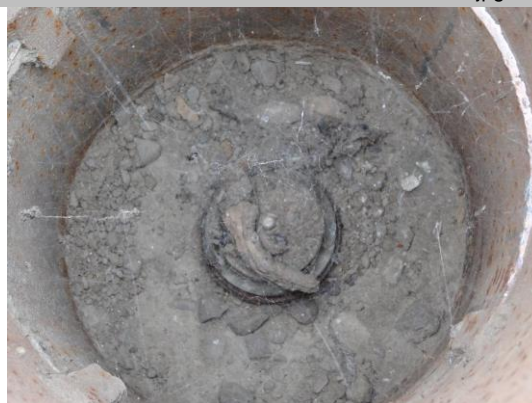
Photo 3 of 3 : UCIP\_FA\_2018\_53363\_44828.jpg

WS view: siphon breaker inside steel pipe riser on levee slope. Needs dirt cleaning/clearing.

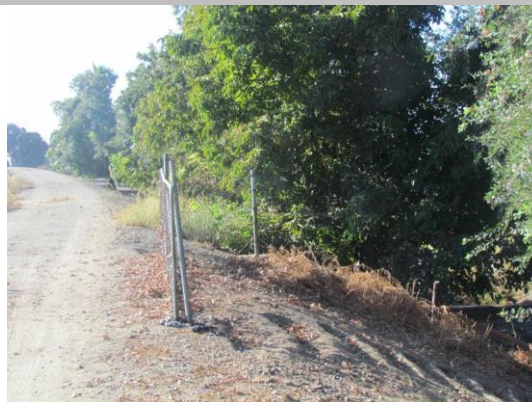
Photo 1 of 1 : FA\_2018\_RD0544\_108\_98\_20180906\_00069.jpg

Looking south at untrimmed trees on landward slope.

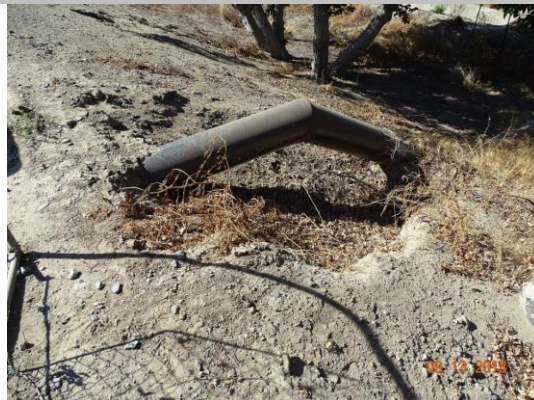
Photo 1 of 3 : FA\_2018\_RD0544\_108\_44\_20180919\_00175.jpg

Looking southwest at erosion around irrigation pipe on landward slope. (Fall 2018)

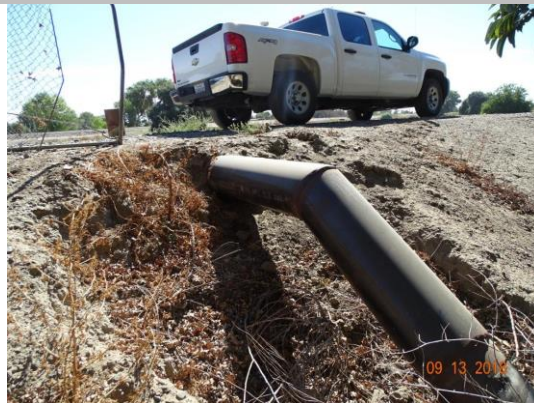
Photo 3 of 3 : FA\_2018\_RD0544\_108\_44\_20180919\_00176.jpg

Looking east at erosion around pipe. (Fall 2018)

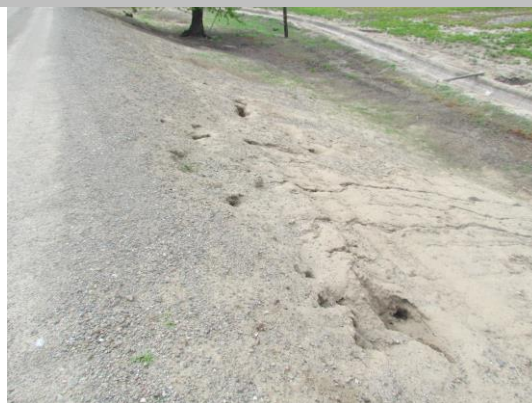
Photo 1 of 1 : FA\_2018\_RD0544\_108\_8\_20180906\_00013.jpg

Looking southwest at several rodent holes on landward shoulder and slope.

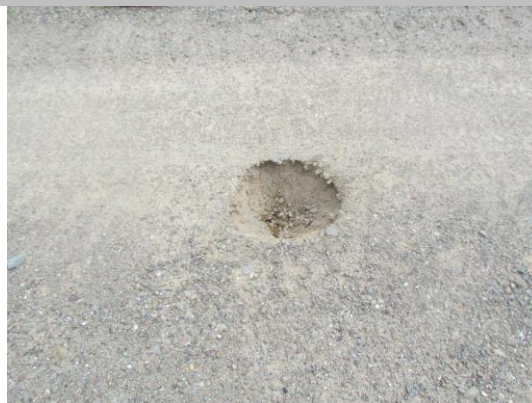
Photo 1 of 1 : FA\_2018\_RD0544\_108\_90\_20180906\_00064.jpg

Looking at sinkhole on levee crown.

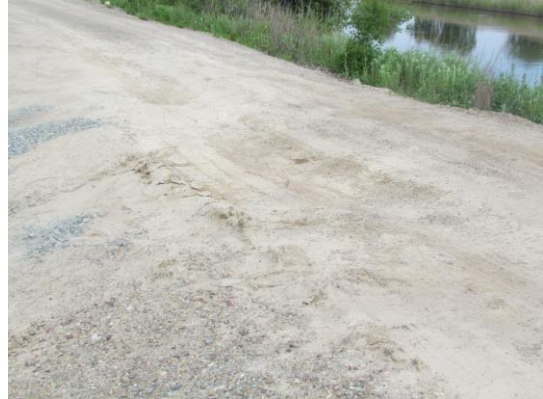
Photo 1 of 1 : FA\_2018\_RD0544\_108\_91\_20180906\_00065.jpg

Looking south at depression on levee crown and landward slope.

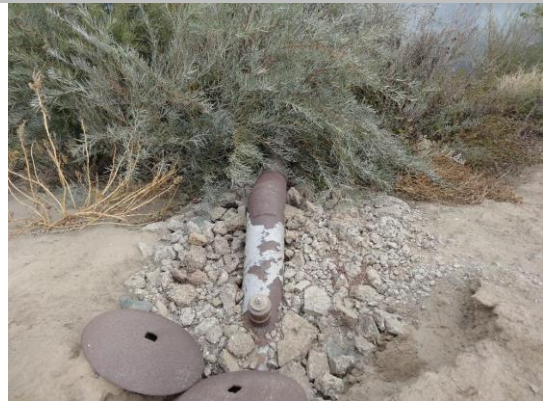
Photo 1 of 3 : UCIP\_FA\_2018\_46671\_44836.jpg

WS view: exposed steel pipe and siphon breaker on levee slope.

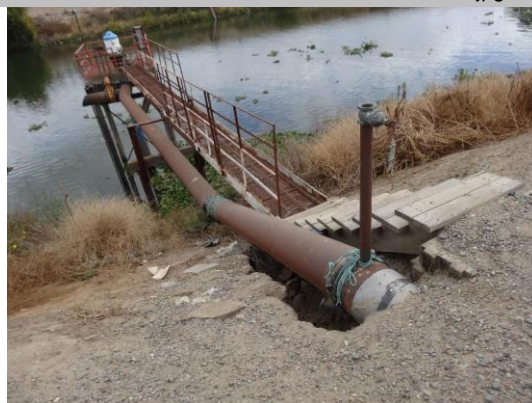
Photo 1 of 3 : UCIP\_FA\_2018\_51361\_44839.jpg

WS view: exposed pipe, walkway to pump, and pump on pile structure in the stream.

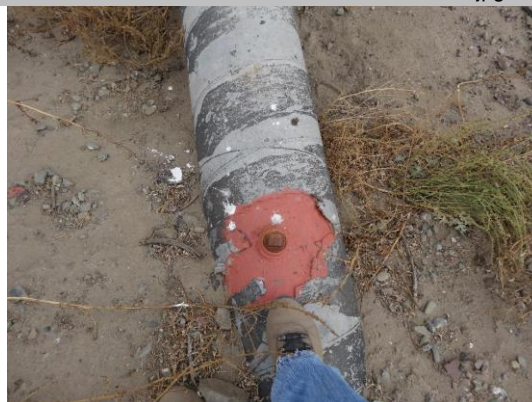
Photo 2 of 3 : UCIP\_FA\_2018\_51366\_44844.jpg

WS view: pipe daylights on levee slope. Siphon breaker removed and plugged.

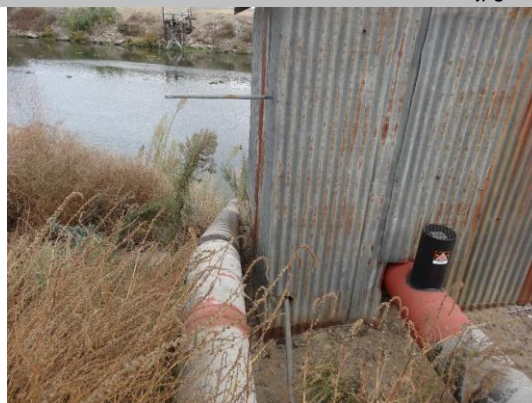
Photo 3 of 3 : UCIP\_FA\_2018\_51366\_44843.jpg

WS view: exposed steel pipe (right) with flow meter near pumphouse.

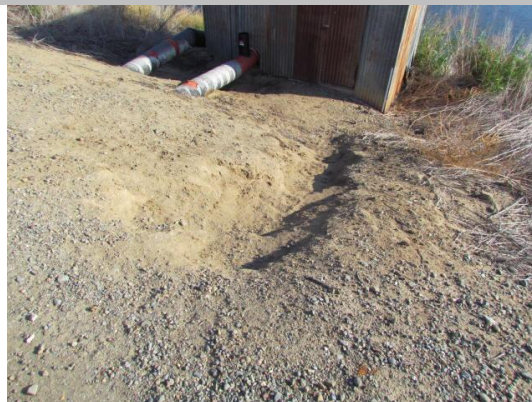
Photo 1 of 1 : FA\_2018\_RD0544\_108\_62\_20180906\_00043.jpg

Looking east at slope damaged by foot traffic near pump house on waterside of levee.

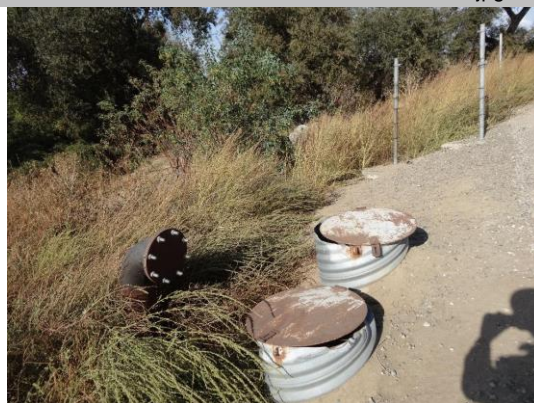
Photo 3 of 3 : UCIP\_FA\_2018\_24893\_44856.jpg

LS view: CMP riser (top- for 12" pipe), CMP riser (bottom- for 16" pipe), and capped steel pipe (left)

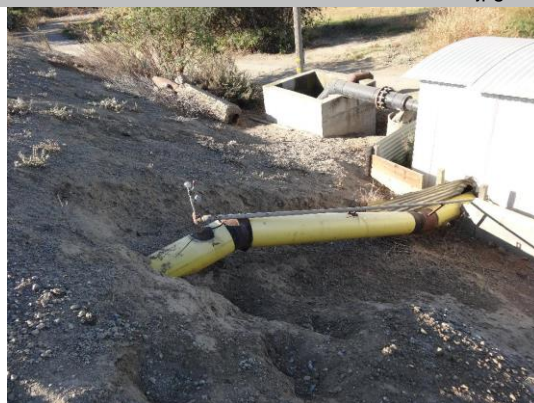
LS view: distribution box (top-left), pumphouse (right) and exposed leaky pipe on eroded levee slope.

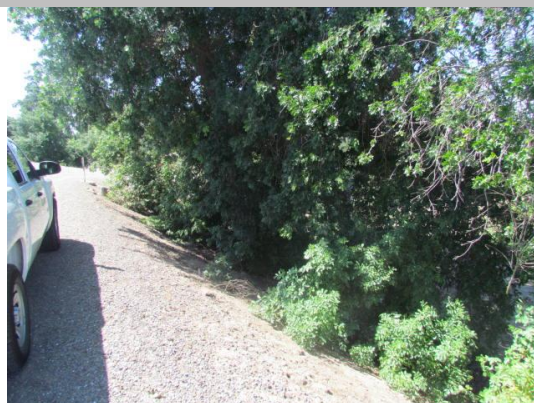
Looking southwest at dense trees on landward slope and toe.

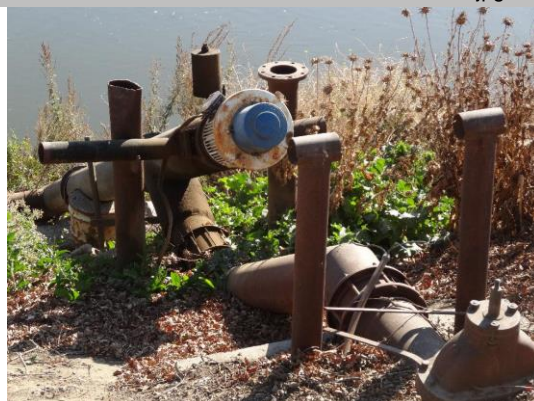
Photo 1 of 3 : UCIP\_FA\_2018\_42962\_42877.jpg

WS view: slant pump on steel framed support, gate valve, and headwall on levee slope.

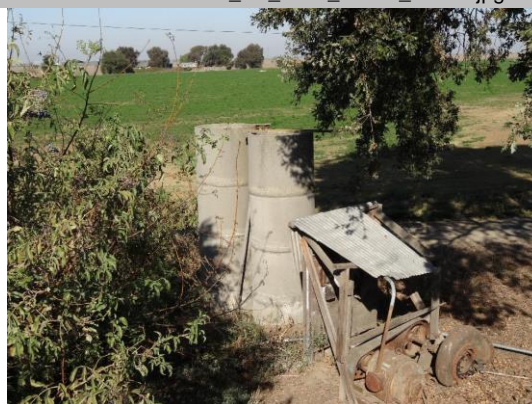
Photo 3 of 3 : UCIP\_FA\_2018\_42962\_42875.jpg

LS view: two concrete standpipes and abandoned pump on levee slope.

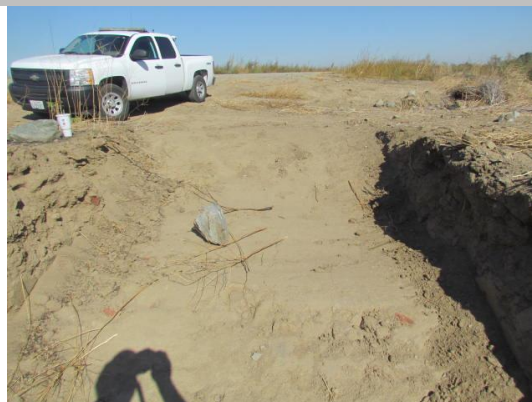
Photo 1 of 4 : FA\_2018\_RD0544\_108\_121\_20180906\_00089.jpg

Looking west at excavation on waterward berm.

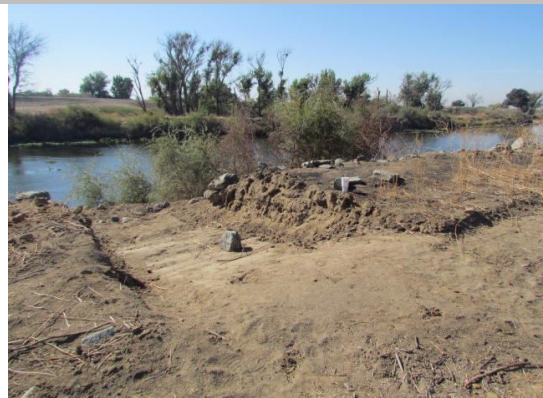
Photo 4 of 4 : FA\_2018\_RD0544\_108\_121\_20180906\_00092.jpg

Looking southeast at excavation on waterward berm.

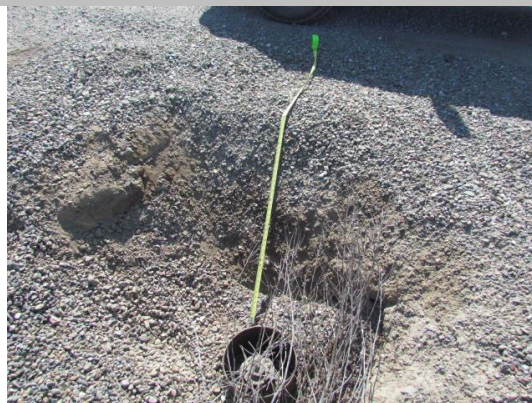
Looking west at caving around siphon on waterside shoulder. (Spring 2012)

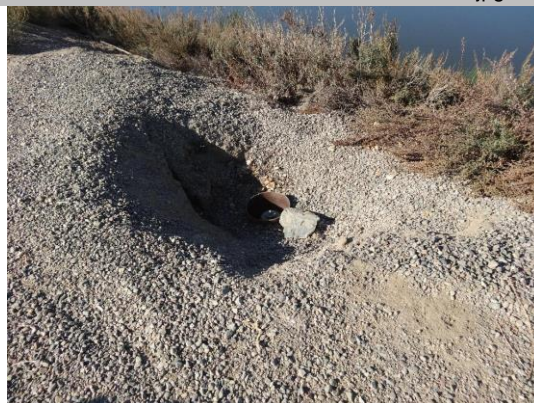
WS view: depression on levee slope around siphon breaker.

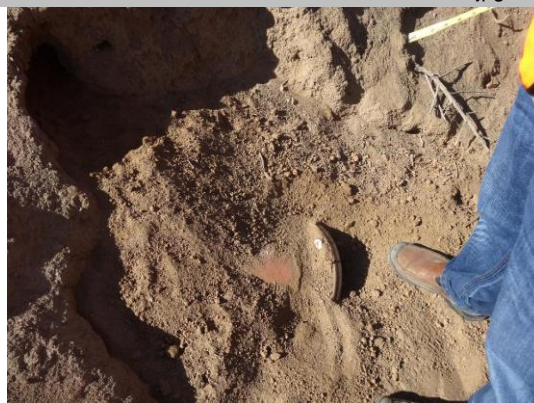
LS view: steel pipe on levee slope with opened end. Levee slope erosion around the pipe.

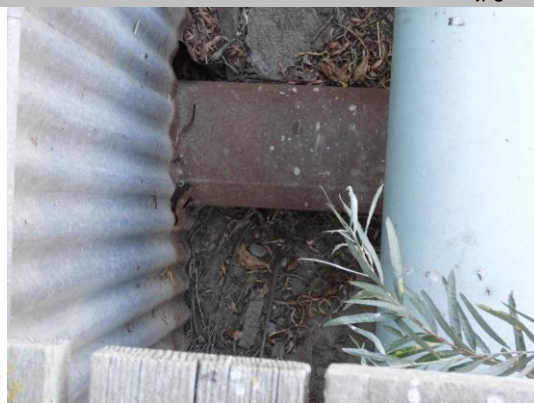
WS view: abandoned 10" steel pipe daylights on levee slope.

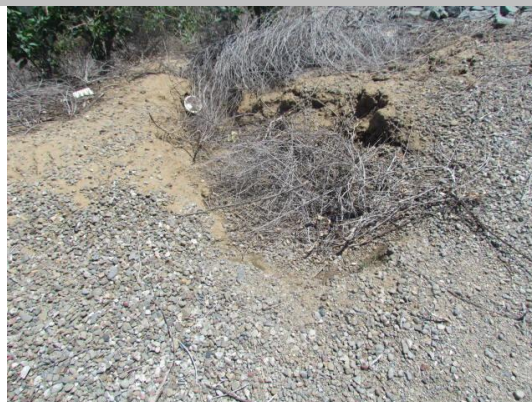
Looking southeast at erosion/caving on waterward slope.

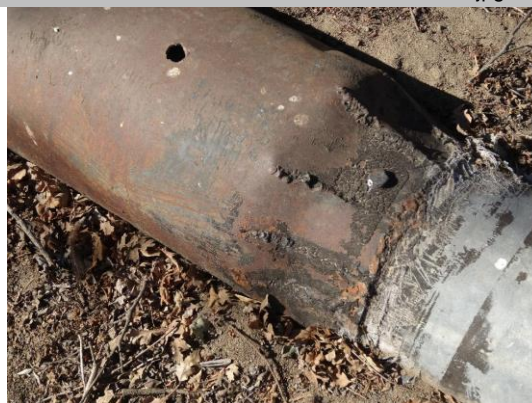
WS view: 12" steel pipe connected to 10" pipe. Holes on pipe top found.

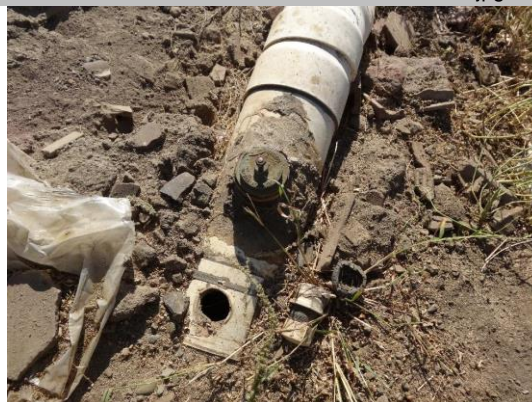
WS view: 8" white pvc pipe with siphon breaker on levee shoulder. An unplugged hole on the pipe.
